Detection and Maintenance of Rolling Contact Fatigue on Railway Steel Rails

Apeh Adejoh Samuel

Department of Civil Engineering, Federal Polytechnic Idah, Kogi State, Nigeria.

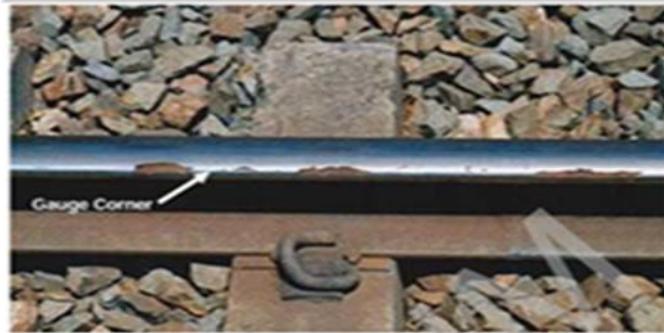
Fig.3 : Corner gauge or shelling

a) Corner gauge or shelling - Shelling normally takes place at the gauge corner of high rails in curves. An elliptical shell like crack propagates in the subsurface parallel to the rail surface. In my study these cracks emerged on the surface, they caused the metal to come out from the crack area. In some cases, these cracks

move in downward direction also, this may probably lead to a transverse fracture of rail. Shelling is a defect caused by loss of material initiated by subsurface fatigue or defect. Steel metallurgy plays an important role in its initiation. Traces of oxide inclusion and residual stress formation during manufacturing contribute to shelling.

i). Corner gauge or shelling defect, is a running surface defect, initiated by the high shear stresses that can develop at the wheel/rail contact region when such stresses exceed the allowable limits for the rail material. If a rail experiences excessive RCF-initiated surface cracking, it needs to be replaced even if it hasn't reached the wear limit.

i). The commonest way of managing corner gauge or shelling is the implementation of a grinding or milling

program which removes just enough rail material to eliminate the cracks but not so much that good rail is ground away.

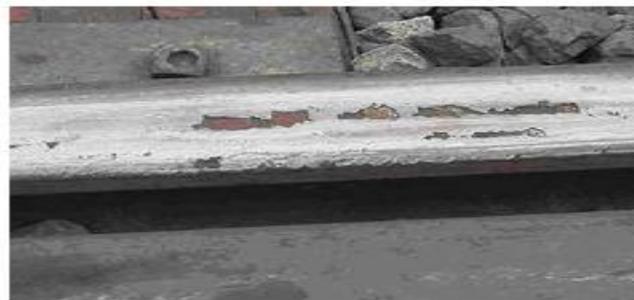
Fig. 4 : Flattened rail head showing displacement of parent metal (spalling)

The surface initiated crack development path is intersected by other similar shallow cracks on the rail head area, where a shallow chip of rail material falls out as seen in Fig. 4. This defect is known as spalling. It occurs at a much later stage of crack propagation phase if it is left uninspected. Spalling is generally referred to as the displacement of parent metal from the rail head.

Spalling originates from high-contact stresses associated with cyclical loading. In the first stages, spalling may be referred to as a slight flaking. Further deterioration increases the amount of metal displacement.

Spalling can be detected by visual inspection and be managed by slight grinding of the running surface.

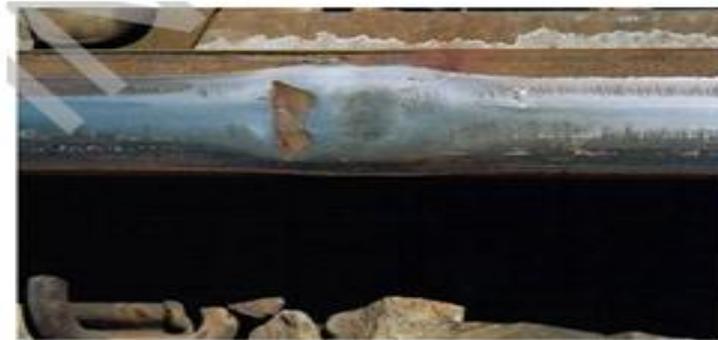
Fig.5: Rrail crown squats

Unlike shelling, squats is a running surface defect that appears in the crown area of straight rail sections (Fig. 5). They are surface initiated defects formed by rolling contact. A squat is formed by two cracks, a leading

crack and a trailing crack. Both cracks propagate in opposite direction. The leading crack proceeds in traffic direction, but the trailing crack propagates faster than the leading one. If preventive measures are not taken quickly, the trailing crack branches out and probably grow downward towards the rail web. Squats seen in this study at the beginning look like a depression in the crown area. The depression is as a result of crack which grows progressively and branches out horizontally just below the running surface, detaching it from the rail body.

i). A squat defect is a particular form of surface-initiated damage that is caused by rolling contact fatigue. Cracking initially propagates at a shallow angle to the surface. When the shallow angled cracks reach a depth of about 3 to 5 millimeters, they tend to turn toward the transverse plane. They are characterised by cracking which initiates on the rail surface and grows down to a point about 3-6mm below the surface. The cracking then spreads along and across the rail, without growing substantially deeper. The rail surface becomes depressed and a dark patch appears due to reduced contact from train wheels. Eventually the rail surface may spall out.

- i). There is a possibility that the secondary or minor sub-surface cracks may turn down and grow on a transverse plane similarly to transverse defects, which could result in a complete rail failure if not detected in time.
- ii). The depression on the running surface associated particularly with large squats also increases the vertical

impact wheel loadings applied to the rails, and consequently exacerbates the deterioration of both track and some vehicle components, in a similar way to dipped welds, rail corrugations and rail joints.

- i). Regular or preventive rail grinding to remove the surface layer, which contains the most severely damaged material, including small cracks and/or hard and brittle phases, so that accelerated crack propagation can be prevented. Periodic or regular grinding are applied to prevent the rapid growth of the cracks. During each preventive grinding cycle, a minimum amount of metal (such as 0.2mm) needs to be removed from the contact surface of the rail. In this way, grinding acts as an artificial rail wear mechanism. These defects could be prevented by grinding. Rail grinding has an important role in reducing rail degradation, thus rail brakes, early rail replacements and derailments are reduced. Removing a few millimeters of metal is just as likely to make things worse. Simply carrying out a normal grind (0.2mm

minimum metal removal) does assist in reducing the impact from vertical irregularity and broadening the contact area. This will slow the growth of squats and the rail deterioration. Light surface grinding of squatty rail can provide temporary relief to noise and vibration issues. More frequent grinding is also desirable at such locations.

ii). Improved rail or wheel lubrication can reduce contamination of the running surface and gauge corner of the rails, and thus reduce the adverse influence of lubrication on the growth of surface initiated fatigue defects.

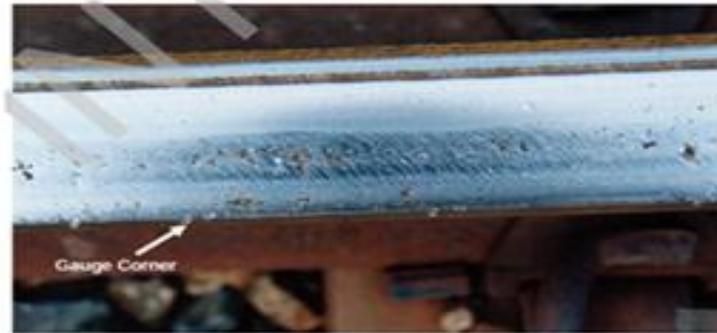
Fig. 6 Running surface checking or flaking

Flaking, or running surface checking, is also a surface condition that occurs on the running surface of the low and/or high rails (Fig. 6). At the beginning, the defects appear as a mosaic or snakeskin like pattern on the rail head. In the latter stages of growth the cracks produce “spalls”, that can be up to about 10-15 mm wide, up to 3 mm deep, and can be continuous along the rail length. In this study, the width of the squat on the rail was 11 mm and 1 mm deep.

i). Rail running defects are initiated by the high shear stresses that can develop at the wheel/rail contact region, when such stresses exceed the allowable limits for the rail material.

- i) They may lead to rail failures if not detected in time, particularly in the case of transverse defects.
- ii) They can mask the ultrasonic signal during routine inspection and hence prevent the detection of larger and deeper defects that may be present within the rail head, including any such defects that may have developed from the shallower initial cracks.

i) The removal of severe rolling contact fatigue (RCF) or defects, and in particular, running surface checking or flaking, is by grinding, an extensive and expensive rail maintenance process.

ii) Installing higher strength rail steels in the more critical track locations, to increase the allowable shear stress limits. Higher strength head hardened rails can be particularly successful in reducing the development of flaking. This is because hardened rails not only exhibit reduced wear, but also reduced plastic deformation.

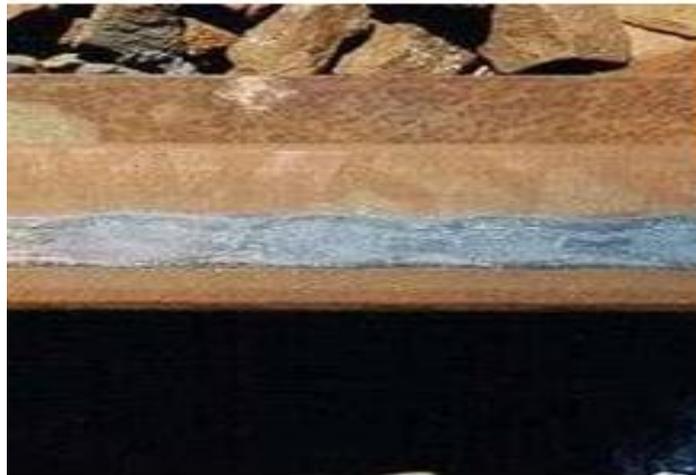
Fig.8 : Short Pitch Corrugations

Corrugation is a rail flaw consisting of the wave-like wearing of the rail tread visualized as peaks and valleys, in other words, it is a periodic irregularity of the rail surface. Rail corrugations are the result of a damage mechanism, such as wear, fatigue or plastic flow operating at some characteristic frequency. Rail corrugations do not cause immediate derailment, but they may cause loosening of rail fastenings, ballast deterioration, increase in noise and vibration level leading to passengers discomfort, etc. Two main types of corrugations which generally occur in rails are: short pitch corrugation and long pitch corrugation.

Short pitch corrugations are considered to be self-excited stick-slip vibration of a wheel set. Defective wheel or defective wheel setting and heavy traffic load may be some of the reasons for this type of corrugation. It is mainly seen in tracks under heavy haul operation. Short pitch corrugation varies between 3 cm to 8 cm.

Long pitch corrugation is characterized by very shallow depth between peaks having very long waves of 8 cm to 30 cm. They are mainly caused by manufacturing defect associated during rolling process of the rails. They are predominant in rails with high traffic density and high speed. However, in this study, it was the short pitch corrugation that was detected because; the measurement of the corrugation detected on the rail surface was 5 cm.

i). Short pitch corrugations are formed due to the differential wear caused by a repetitious longitudinal sliding action of the wheel on the rail, whether through acceleration, braking or lateral motion across the rail. The longitudinal oscillations were probably developed due to the excitation of the torsional resonance of the wheel set.

i). Rail corrugations are of concern because they increase the dynamic wheel loads and vibration, leading to the deterioration and failure of various track and vehicle components.

ii). Higher dynamic loads also increase the rate of corrugation development and the rate of rail profile deterioration. The rails therefore require more maintenance effort, such as grinding, at shorter intervals. Corrugations also increase, considerably, the wheel/rail noise.
